70-86 LYNN WILLIAMS STREET

HERITAGE IMPACT ASSESSMENT

Issued: October 2, 2023

Project # 15-071-06
Prepared by AP / DE / CS / ZA

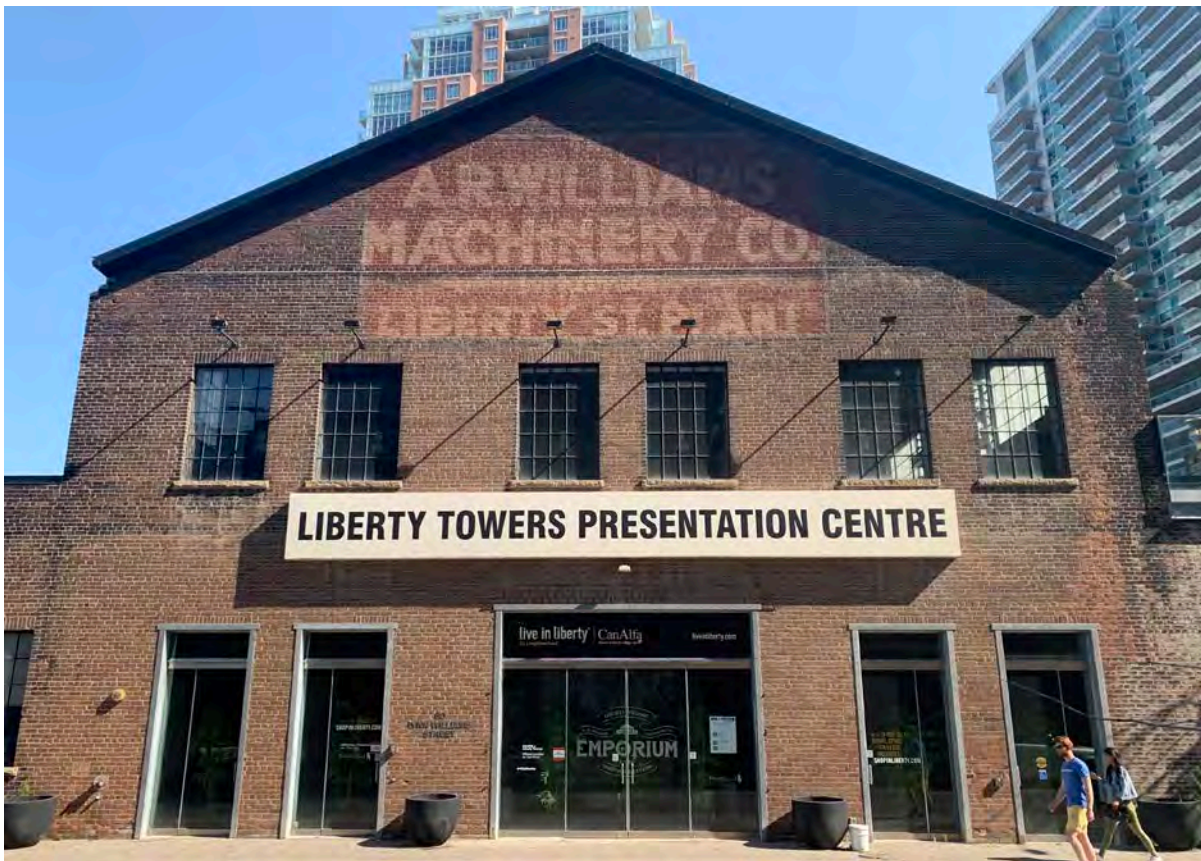
Figure 7. Central portion of the south elevation (ERA, 2023).

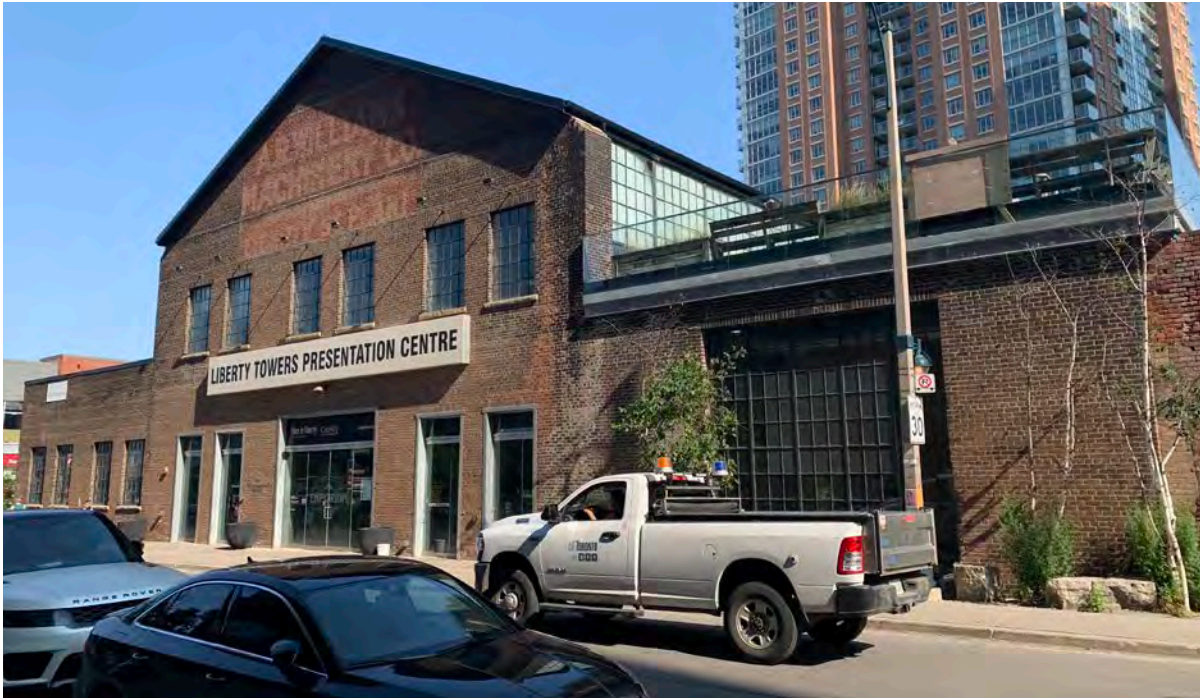
Figure 8. South elevation (ERA, 2023).

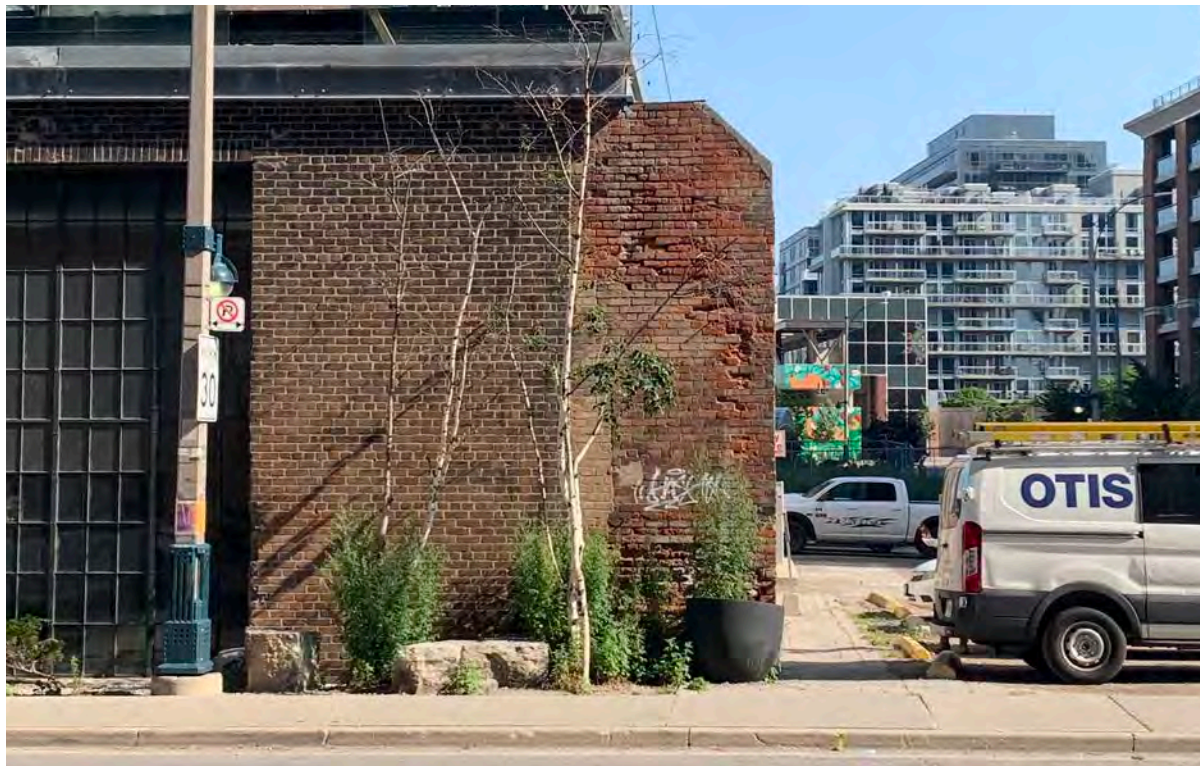
Figure 9. South elevation showing wall remnant (ERA, 2023).

- The east elevation and south wall remnants of the Central Prison Complex are in poor condition and have been altered. Although one of only two remaining elements from the Central Prison complex, these remnants are a small portion of the former building within the large complex, and do not convey the wholeness of that complex.

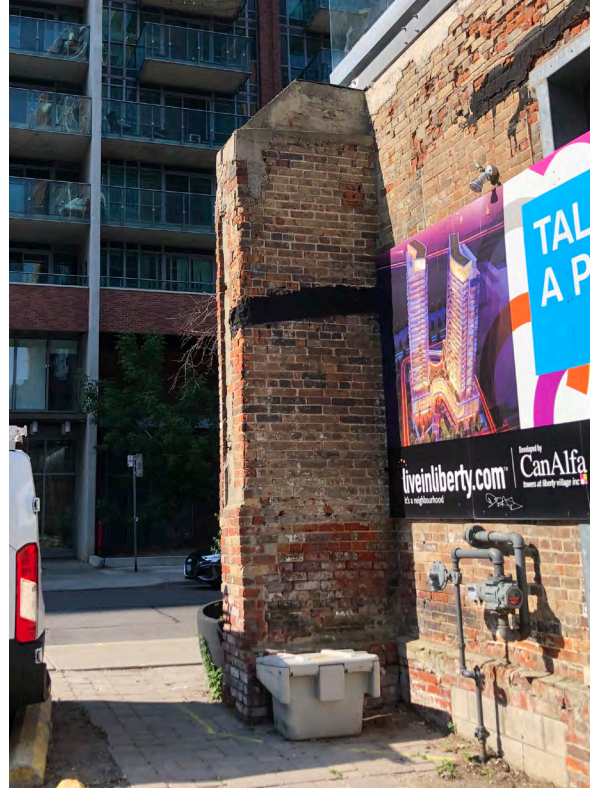
Figure 11. North elevation of wall remnant (ERA, 2023).

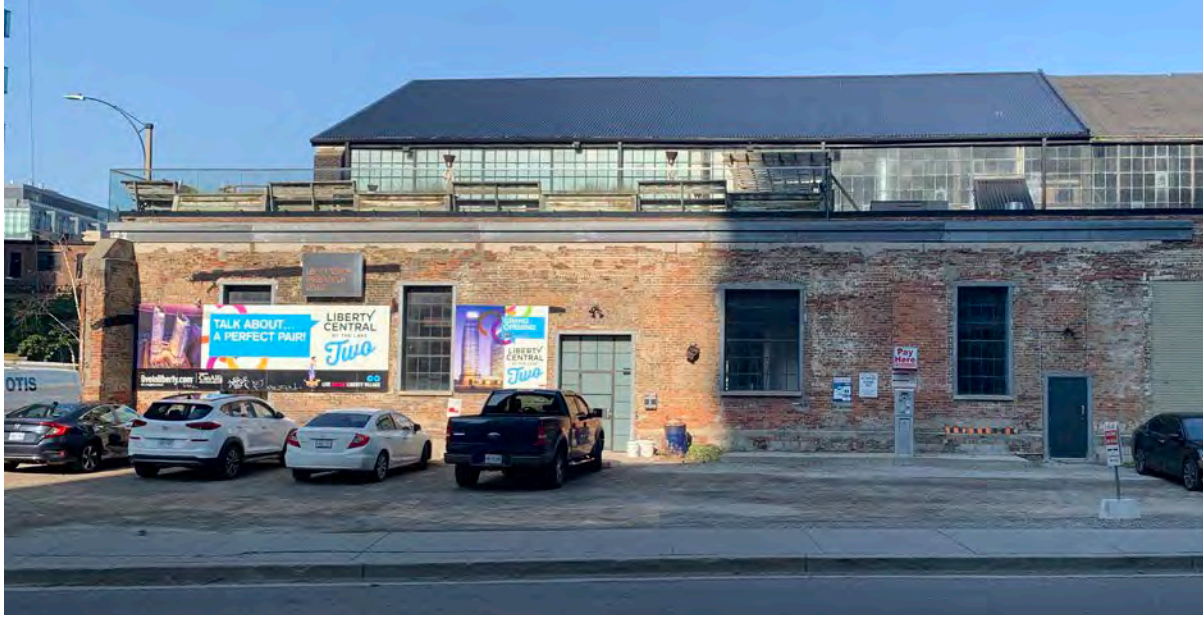
Figure 13. Southern portion of east elevation (ERA, 2023).

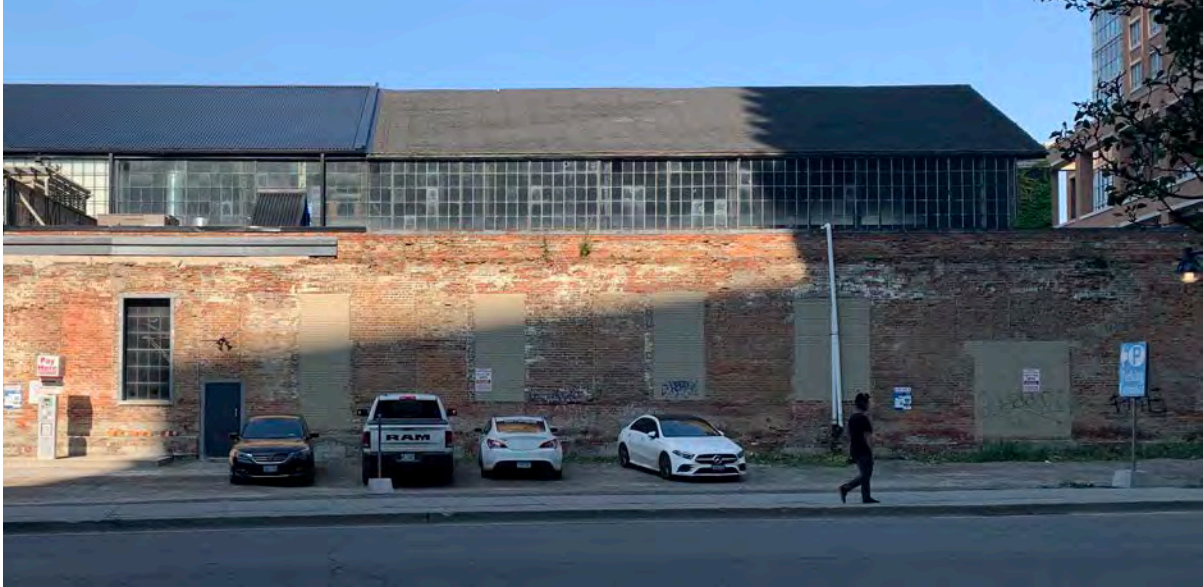
Figure 15. Northern portion of east elevation (ERA, 2023).

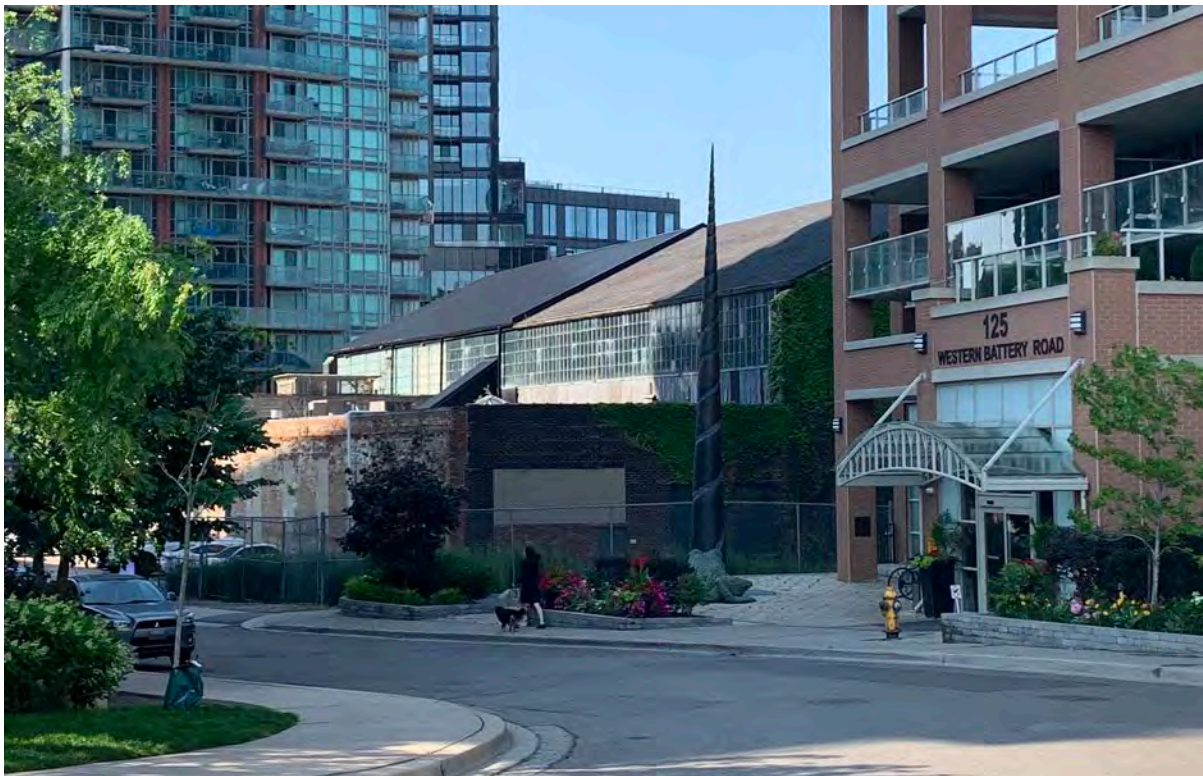
Figure 16. Context photo looking southwest along Western Battery Road (ERA, 2023).

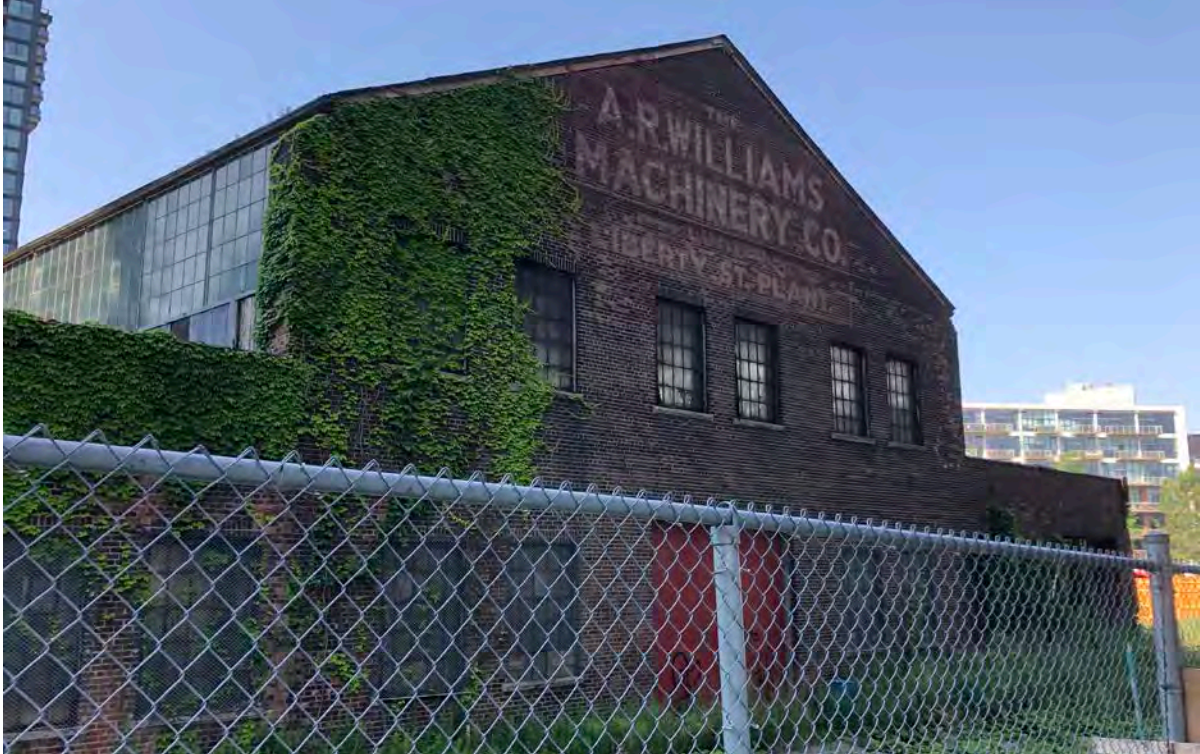
Figure 17. North elevation (ERA, 2023).

- The northern portion of the building has been altered and is in poor condition. Changes include alterations to the structure, and openings which have been filled in. This section retains some original elements, including its double-height space, clerestory windows, steel framing, and a gantry crane. The gable roof form is intact, however the low roof at the northern portion of the building is defective.

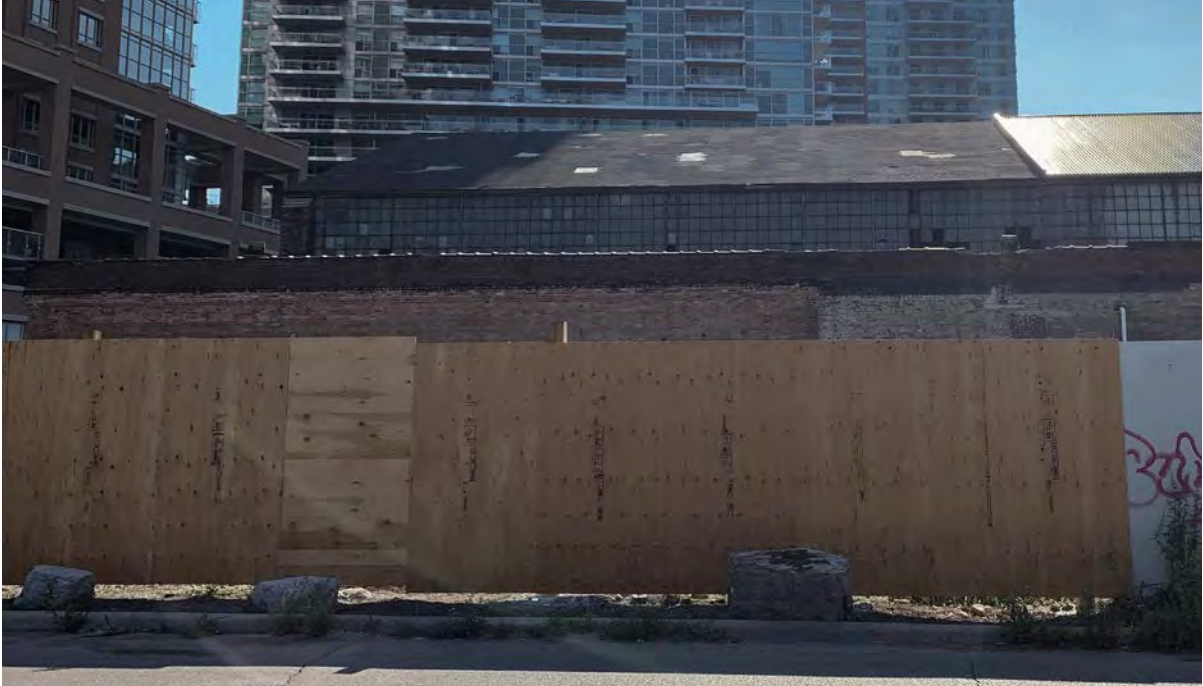
Figure 19. Northern portion of west elevation (ERA, 2023).

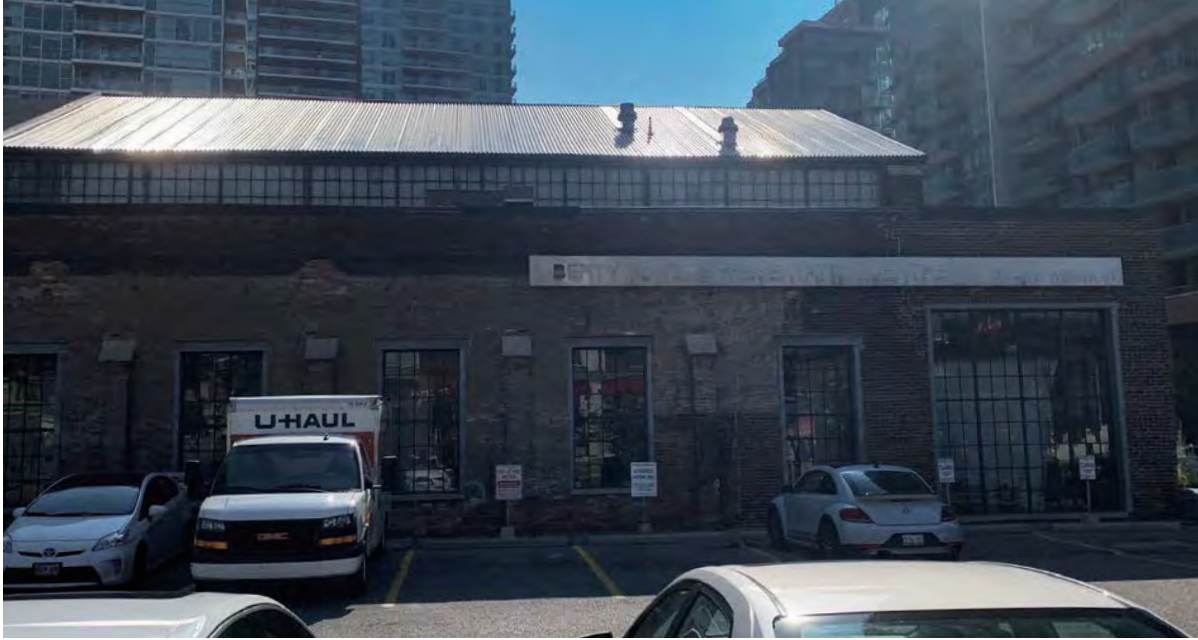
Figure 21. Southern portion of west elevation (ERA, 2023).

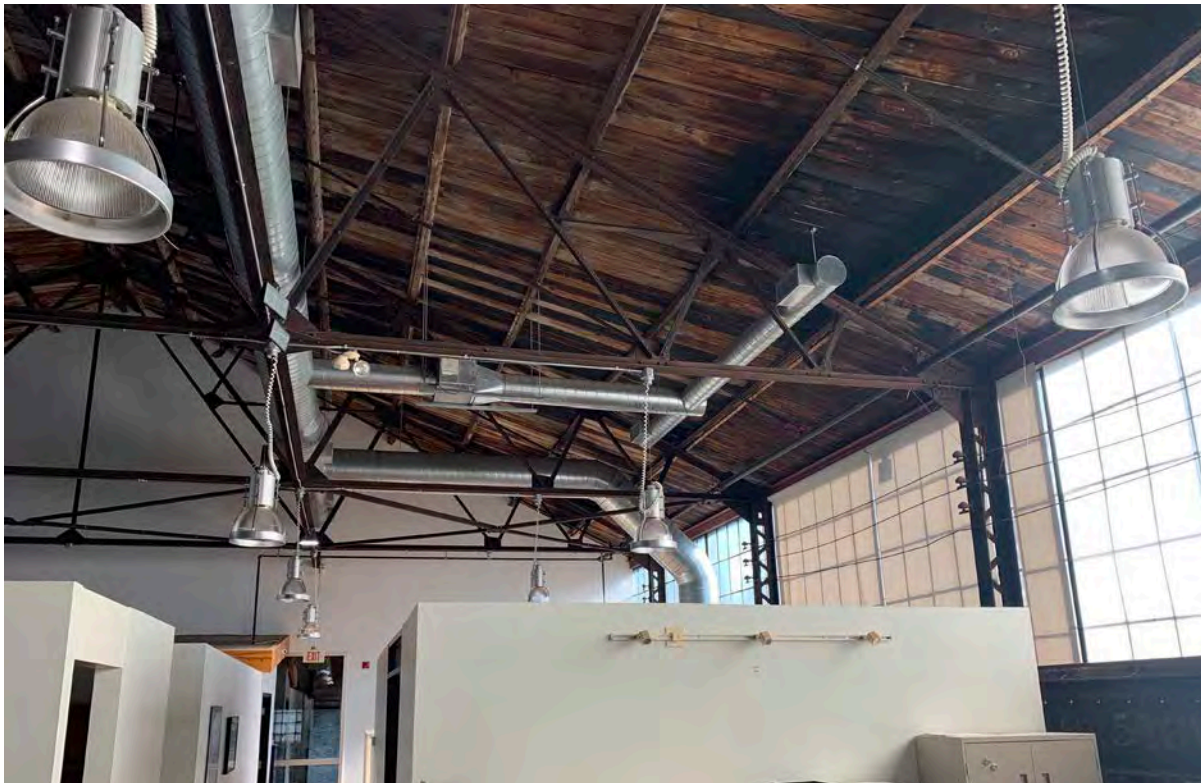
Figure 22. Interior of the second storey with the interior partition between the north and south portions of the building. The steel frame support and open span roof is visible (ERA, 2023).

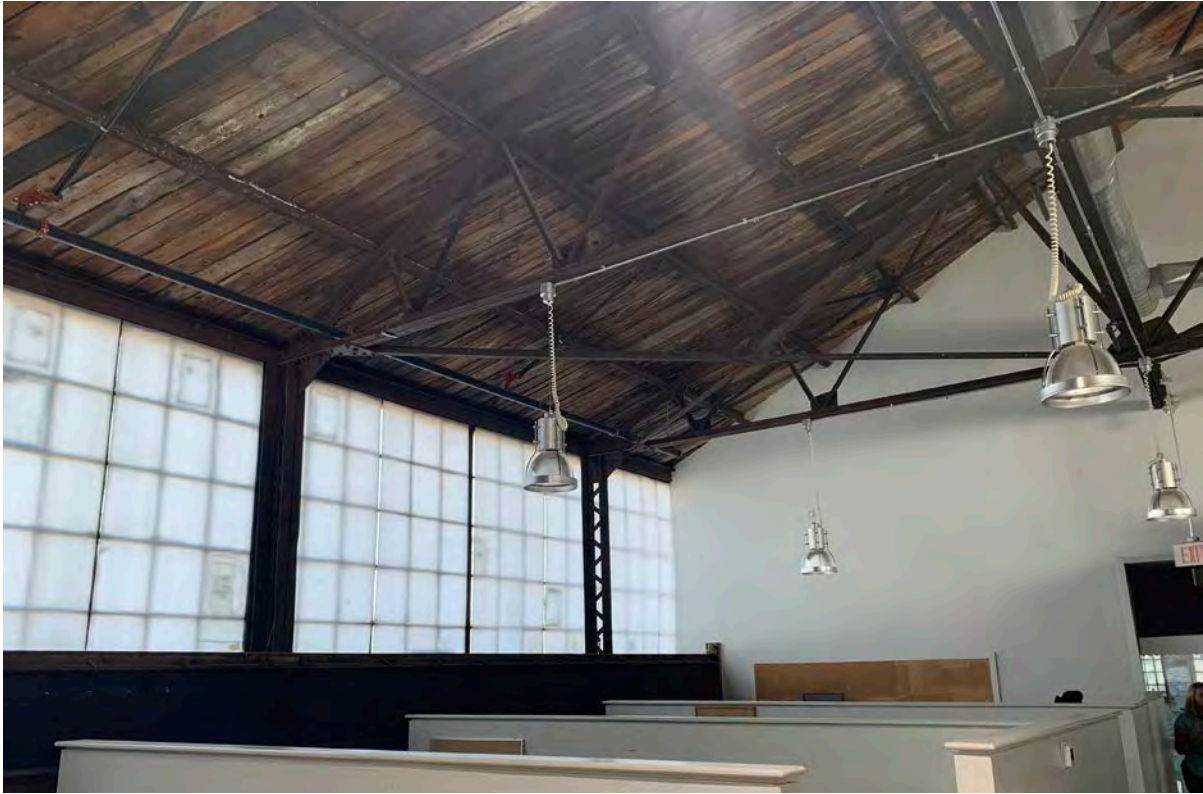
Figure 23. Interior looking northwest showing the clerestory windows and open span roof of the southern portion of the building (ERA, 2023).

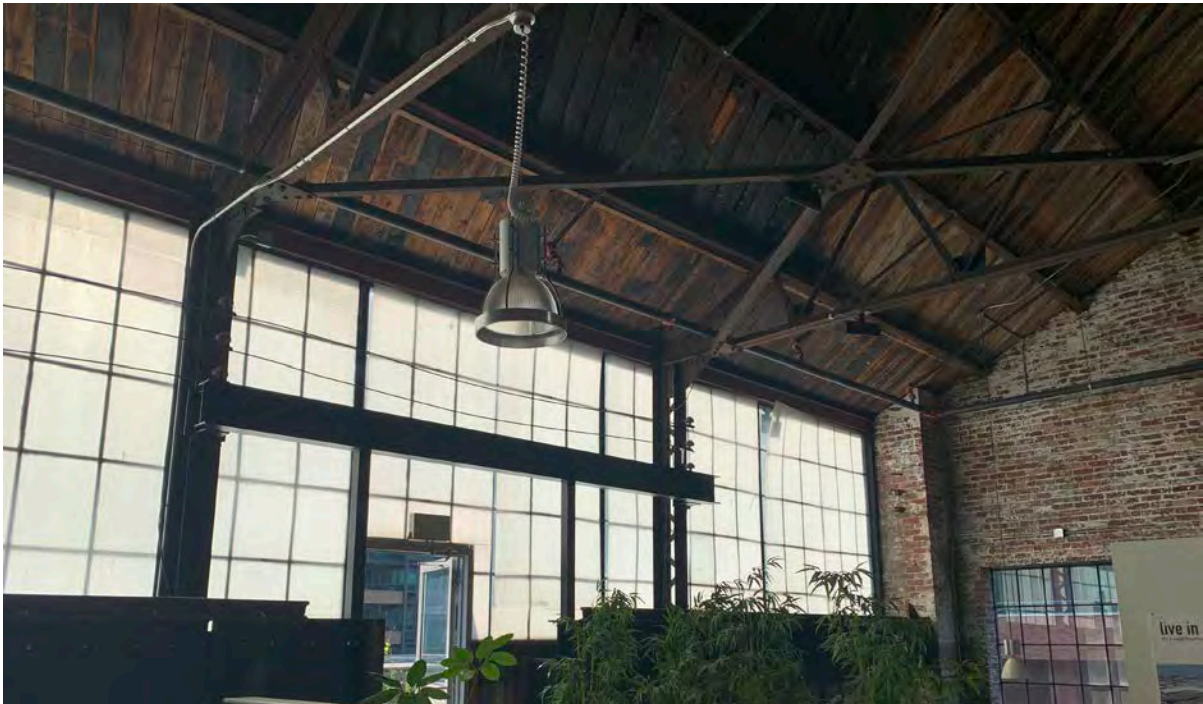
Figure 24. Interior looking southeast showing the clerestory windows on the southern portion of the building (ERA, 2023).

- The southern portion of the building has been altered and is in fair condition. Changes include modified openings, a new roof terrace, new roofing, changes to the building interior including the construction of a new mezzanine, modified floor levels with a new finished floor, and removal of sections of the gantry crane track. This section retains some original elements, including clerestory windows, steel columns and trusses.

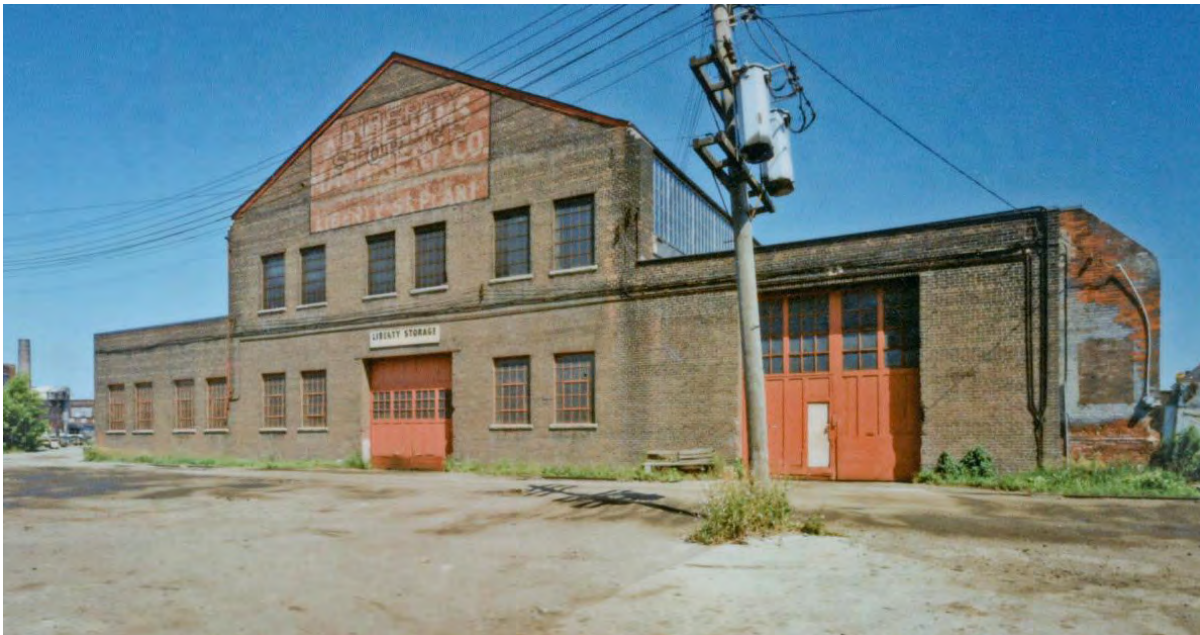
Figure 33. 1987 photo of the south elevation of the Site. The remaining portion of the Broom Factory/Paint Shop wall is visible to the east (right). The large opening on the eastern portion of the south elevation may have been used for a railway siding (Toronto Public Library).

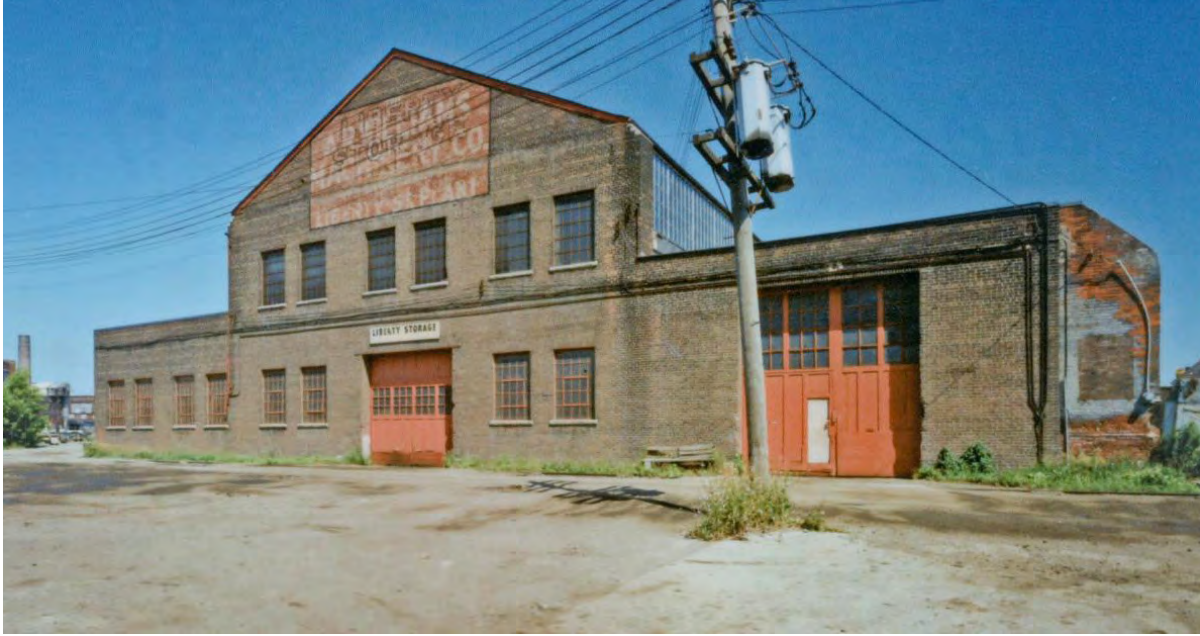
Figure 48. 1987 photo of the south elevation of the Site. The remaining portion of the Broom Factory/Paint Shop wall is visible to the east (right). The large opening on the eastern portion of the south elevation may have been used for a railway siding (Toronto Public Library).

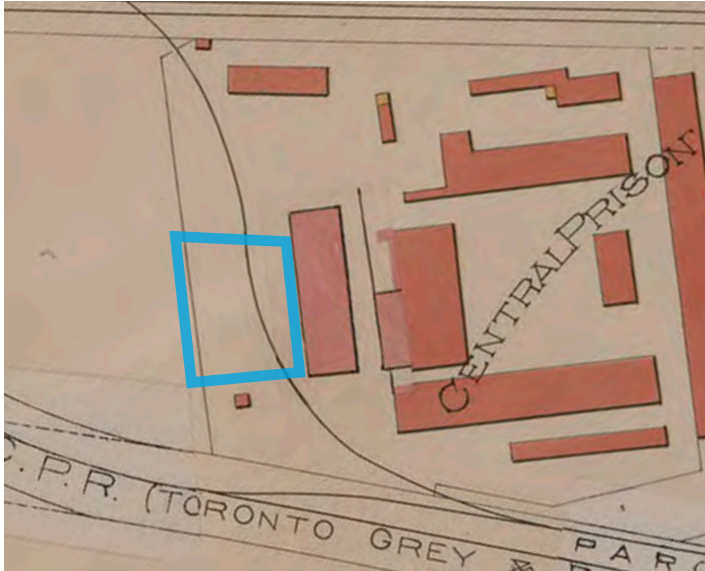
Figure 59. 1903 Goad's Insurance Map showing the boundary of the building on the Site. Additional buildings in the Central Prison complex have been built including the brick building to the east which includes the Broom Factory (City of Toronto; annotated by ERA).

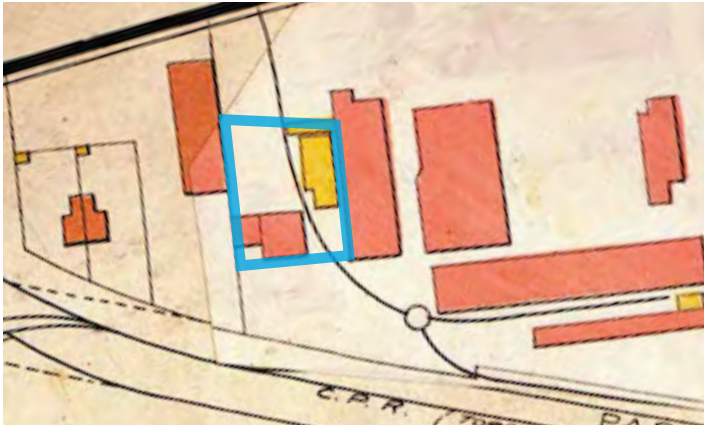
Figure 61. 1924 Goad's Insurance Map showing the boundary of the building on the Site. At this point the Toronto Central Prison has been shut down and undergoing gradual demolition. Two small brick and wood buildings have been constructed on the Site. (City of Toronto; annotated by ERA).

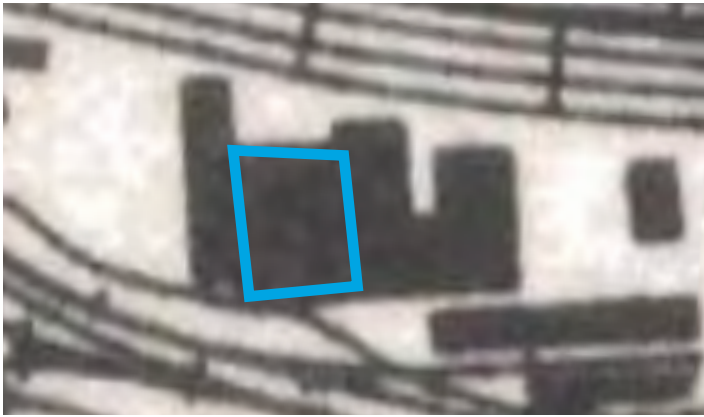
Figure 62. 1934 Army Survey Establishment map showing the boundary of the building on the Site (built in 1929) and surrounding buildings (University of Toronto Map & Data Library; annotated by ERA).

- Figure 62. 1934 Army Survey Establishment map showing the boundary of the building on the Site (built in 1929) and surrounding buildings (University of Toronto Map & Data Library; annotated by ERA).

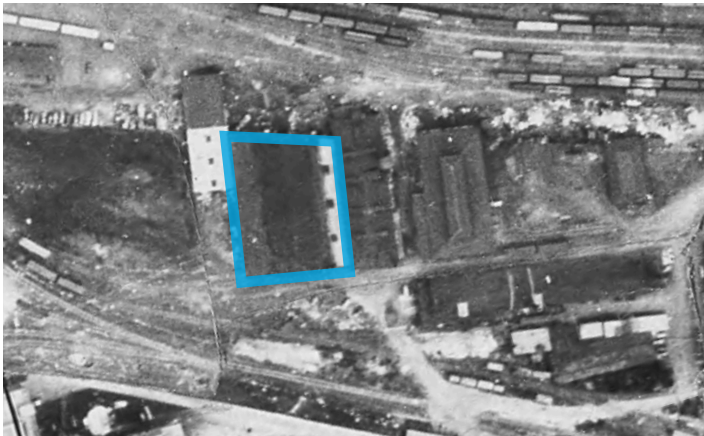
Figure 63. 1947 aerial photo of building on the Site showing its proximity to rail (City of Toronto; annotated by ERA).

- Figure 63. 1947 aerial photo of building on the Site showing its proximity to rail (City of Toronto; annotated by ERA).
- Figure 64. 1956 aerial photo of building on the Site (City of Toronto; annotated by ERA).

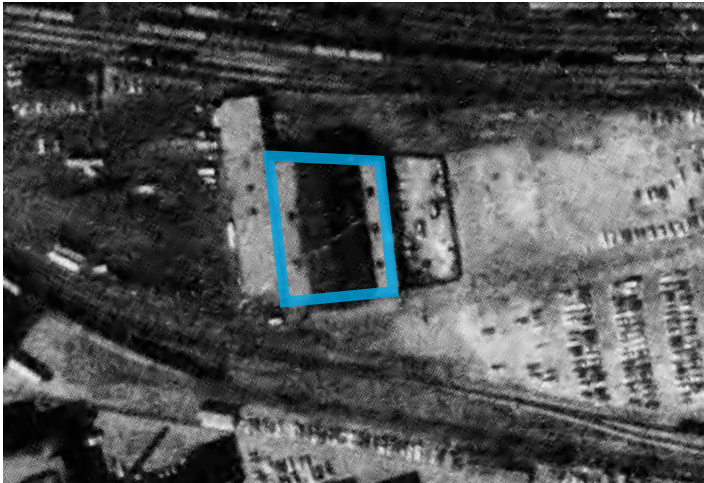
Figure 67. 1981 aerial photo of building on the Site. The building to the east appears to have been demolished as well as the building further east (City of Toronto; annotated by ERA).

- Figure 67. 1981 aerial photo of building on the Site. The building to the east appears to have been demolished as well as the building further east (City of Toronto; annotated by ERA).

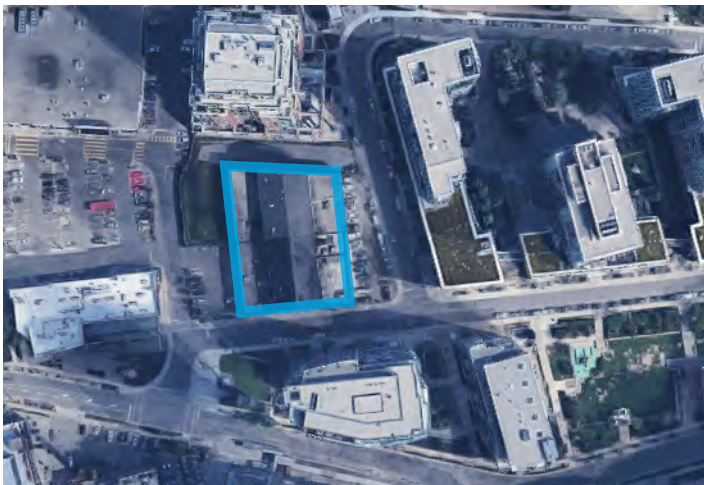
Figure 71. 2023 aerial photo of building on the Site (Google Earth; annotated by ERA).

- Figure 70. 1991 aerial photo of building on the Site. By this time, the building to the west was demolished (City of Toronto; annotated by ERA).
- Figure 71. 2023 aerial photo of building on the Site (Google Earth; annotated by ERA).

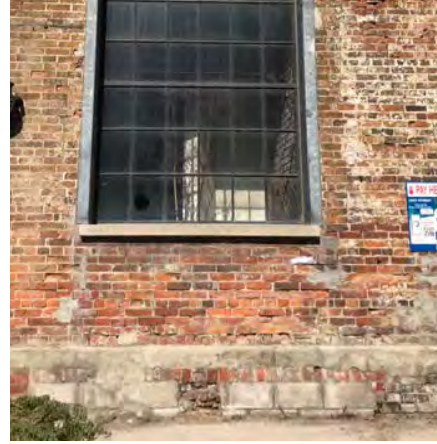
Minor staining is visible on the facade, concentrated under the stone sills. Minor efflorescence is also visible at grade level. The east side of the facade adjacent entries shows significant efflorescence as well. There are deteriorated jambs on the large window on the east side of the facade with significant efflorescence. The existing metal lintel on east side appear to have spalling masonry around the leading edge of steel. The south portion of the remaining Broom Factory wall is in poor condition with significant masonry deterioration throughout with efflorescence and recessed mortar joints visible.

Figure 73. Detail of staining beneath the stone sill (ERA, 2023).

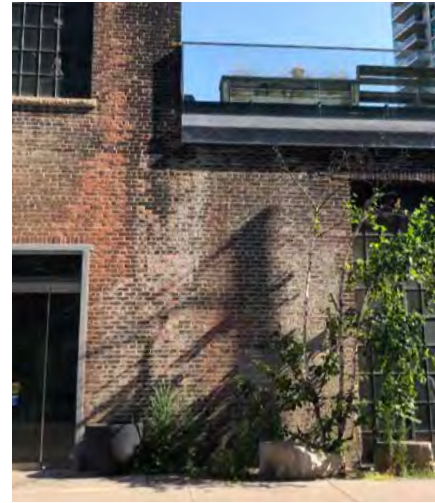
Figure 74. Detail of facade efflorescence (ERA, 2023).

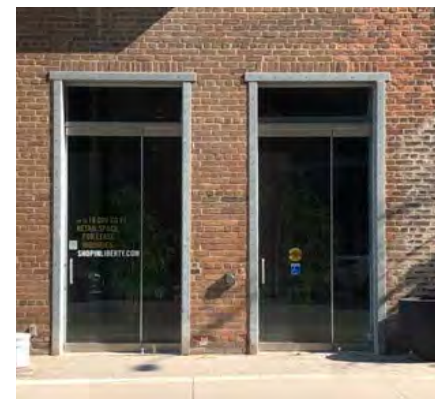
Figure 75. Entrance doors surrounded by galvanized steel plates (ERA, 2023).

- Figure 74. Detail of facade efflorescence (ERA, 2023).
- Figure 75. Entrance doors surrounded by galvanized steel plates (ERA, 2023).
- Figure 76. Detail of spalling and joint deterioration (ERA, 2023).

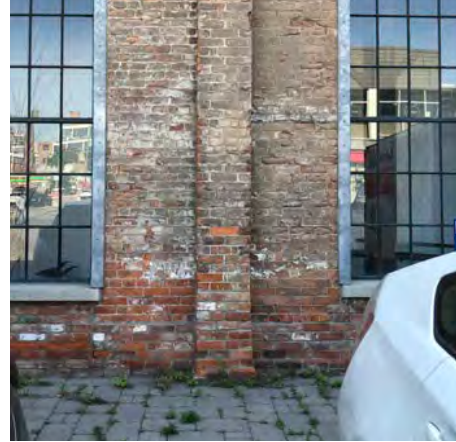
There are step cracks which have been previously infilled, some with caulking. There is consistent spalling and joint deterioration visible at-grade and selective spalling apparent throughout the facade which has exposed the softer red interior body of the bricks. Efflorescence was present at localized areas and paint remnants are visible on the facade in selective locations. Graffiti was also visible in some locations. Roofing bituminous coatings are visible at the parapet level. Galvanized metal jambs also appear to be in good condition.

Figure 76. Detail of spalling and joint deterioration (ERA, 2023).

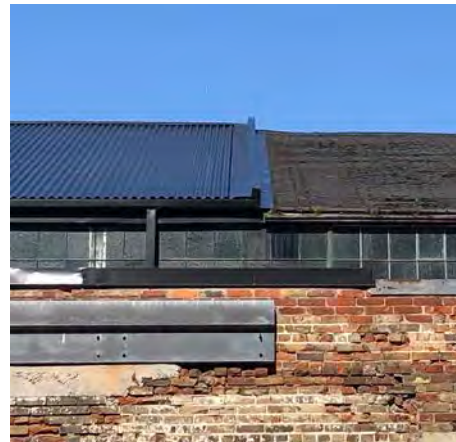
Figure 77. Detail of step cracking and bituminous coating at the parapet level (ERA, 2023).

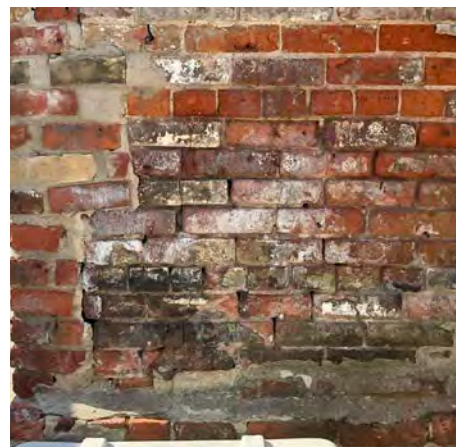
The single-storey west wing and elevation was built with the gable end wall in 1929 and matches its brick construction. The masonry has been repaired previously and the replacement masonry appears to be in orange brick, inconsistent with the original bricks. There are also localized areas of recessed mortar joints as well as metal fasteners visible in the masonry.

Figure 78. Detail of masonry with remnants of paint and recessed mortar joints (ERA, 2023).

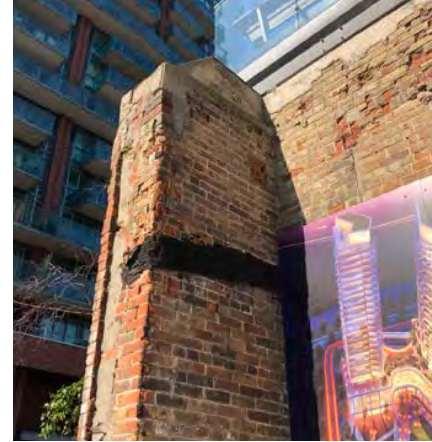
A concrete cap has been added to the top of the wall. Given that concrete does not have the same material properties as brick in terms of movement due to expansion and contraction and level of porosity, areas of brick adjacent to the concrete cap show accelerated deterioration.

Figure 79. Detail of remnant of Broom Factory wall with a cast concrete cap (ERA, 2023).

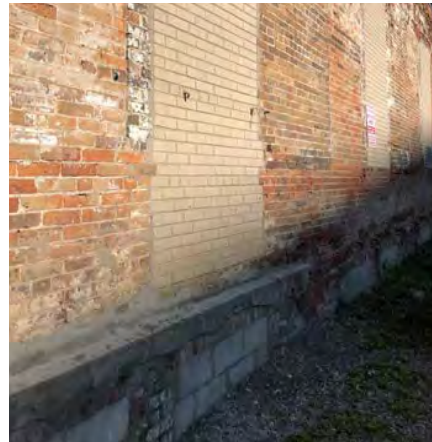
Figure 80. Detail of concrete block infill at-grade (ERA, 2023).

- Figure 79. Detail of remnant of Broom Factory wall with a cast concrete cap (ERA, 2023).
- Figure 80. Detail of concrete block infill at-grade (ERA, 2023).

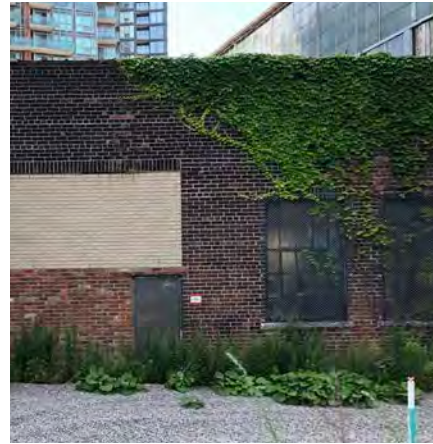
Figure 81. Detail of brown facing brick (ERA, 2023).

- Figure 81. Detail of brown facing brick (ERA, 2023).
- Figure 82. Original metal, single-glazed windows (ERA, 2023).
- Figure 83. Interior detail of original steel structured roof (ERA, 2023).

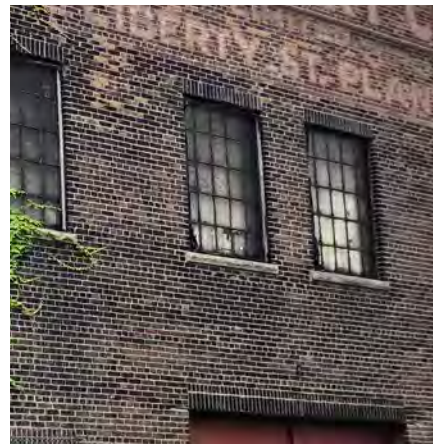
Figure 82. Original metal, single-glazed windows (ERA, 2023).

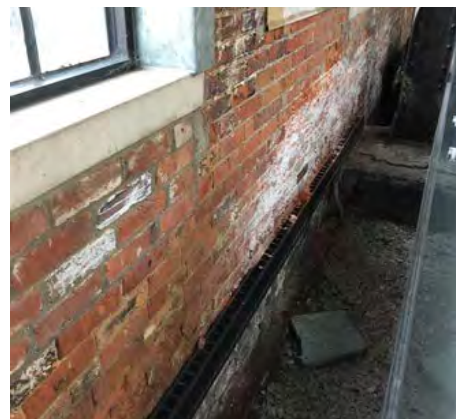
Figure 85. Interior detail of localized brick spalling at-grade (ERA, 2023).

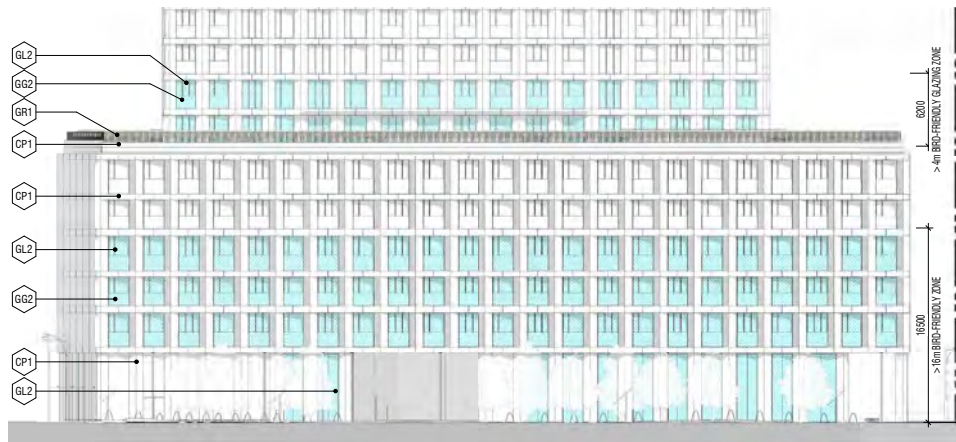
Figure 88. Proposed north elevation (gh3, 2023).

- Figure 86. Proposed site plan (gh3, 2023).
- Figure 87. Proposed ground floor plan (gh3, 2023).
- Figure 88. Proposed north elevation (gh3, 2023).
- Figure 89. Proposed south elevation (gh3, 2023).

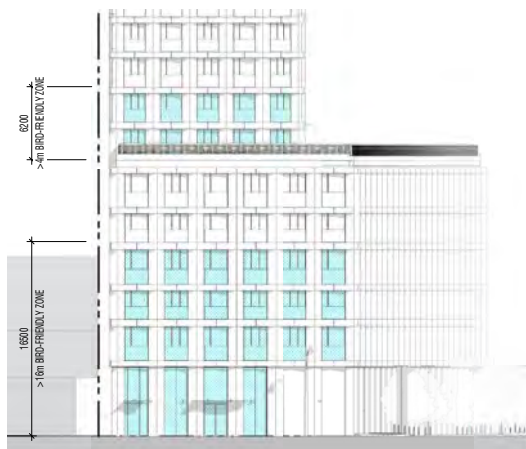
Figure 90. Proposed east elevation (gh3, 2023).

- Figure 90. Proposed east elevation (gh3, 2023).
- Figure 91. Proposed west elevation (gh3, 2023).
- Figure 92. Proposed ground floor plan showing the retained building in blue and the footprint of the demolished portion in red (gh3, 2023; annotated by ERA).

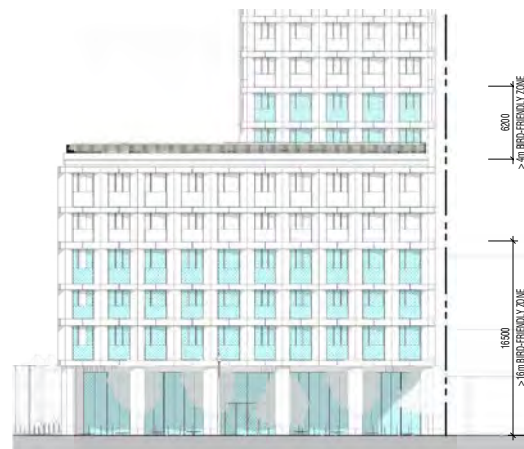
Figure 91. Proposed west elevation (gh3, 2023).

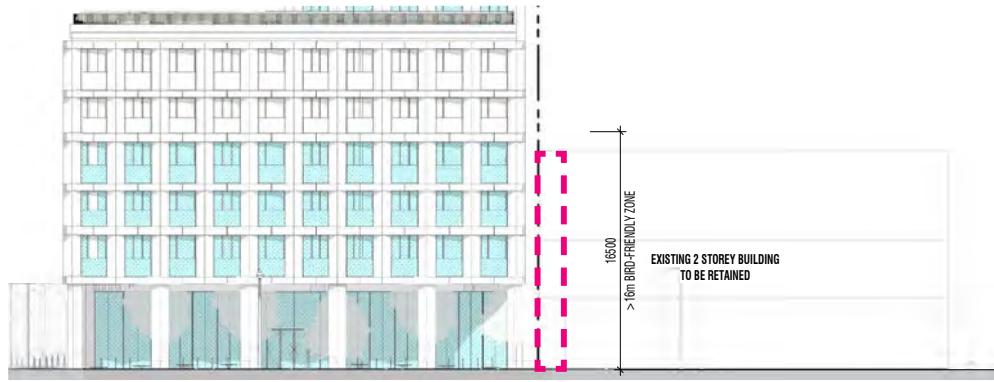
Figure 93. West elevation with the location of the proposed atrium in pink (gh3, 2023; annotated by ERA).

- Figure 93. West elevation with the location of the proposed atrium in pink (gh3, 2023; ; annotated by ERA).
- Figure 94. Existing and proposed elevations showing the proposed atrium openings (IBI, 2023; annotated by ERA).

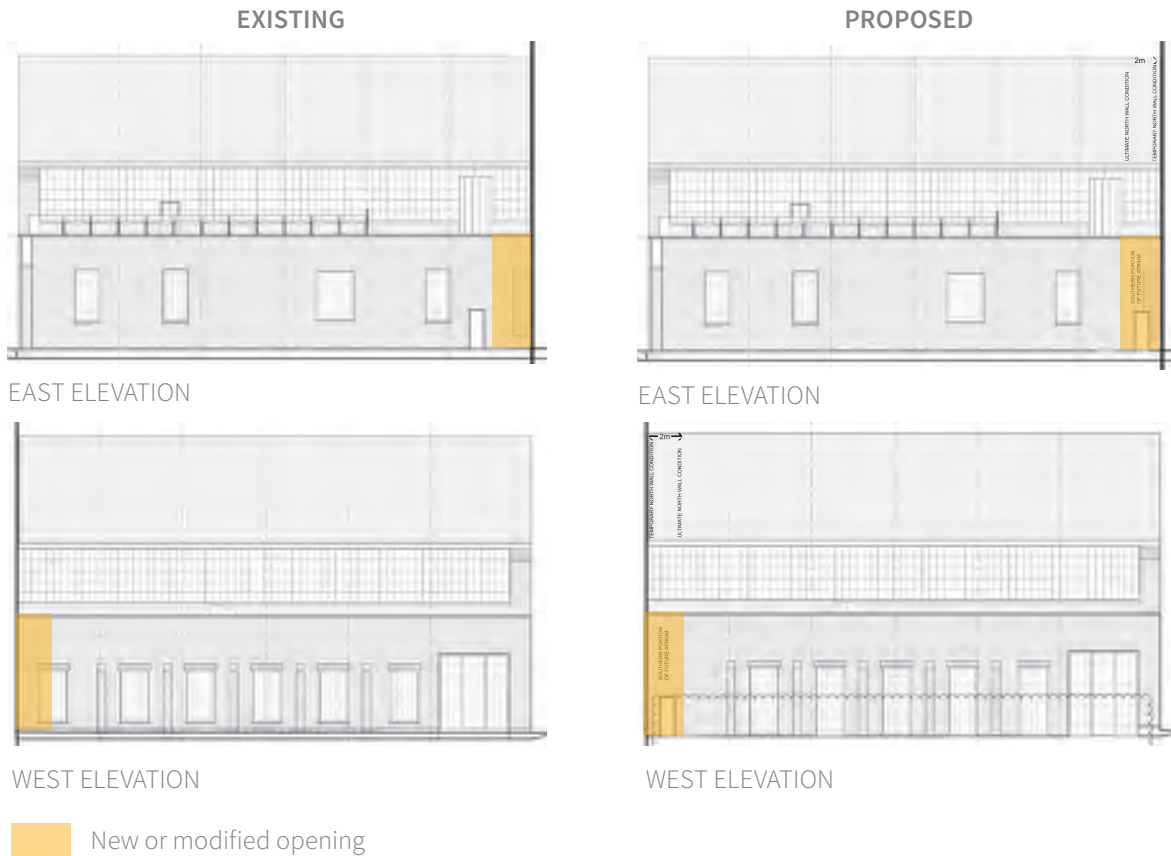
Figure 94. Existing and proposed elevations showing the proposed atrium openings (IBI, 2023; annotated by ERA).

Impact: Partial demolition of east and west walls at ground floor level at the northern extent of the retained building.

Rationale and Mitigation: The approximate two-metre wide band running east-west will be modified in order to allow for a new atrium that will function as a mid-block pedestrian connection and provide access points to the retained building and the proposed development. The atrium will be accessible from the east and west elevations. The partial demolition of the east and west walls will be mitigated by the retention and conservation of the steel structure, including columns and truss, clerestory windows, and low and high roof profile.

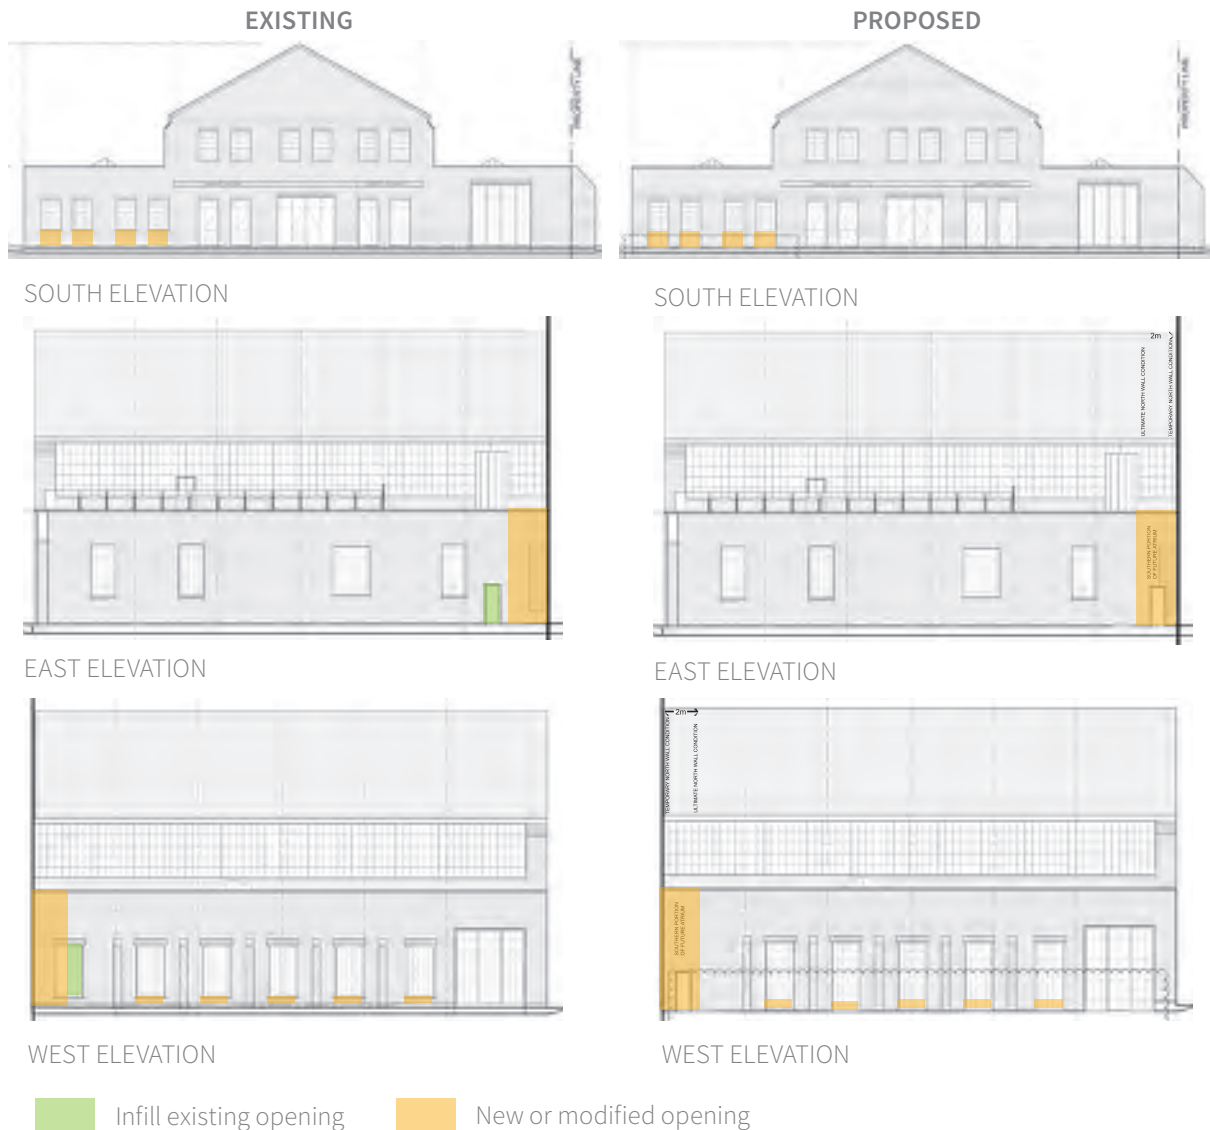
Figure 95. Existing and proposed elevations showing modifications to the openings for the retained building (IBI, 2023; annotated by ERA).

Impact: Modification to select openings on the east, south, and west elevations of the retained building.
