70-86 LYNN WILLIAMS STREET

HERITAGE IMPACT ASSESSMENT

Issued: October 2, 2023

Project # 15-071-06
Prepared by AP / DE / CS / ZA

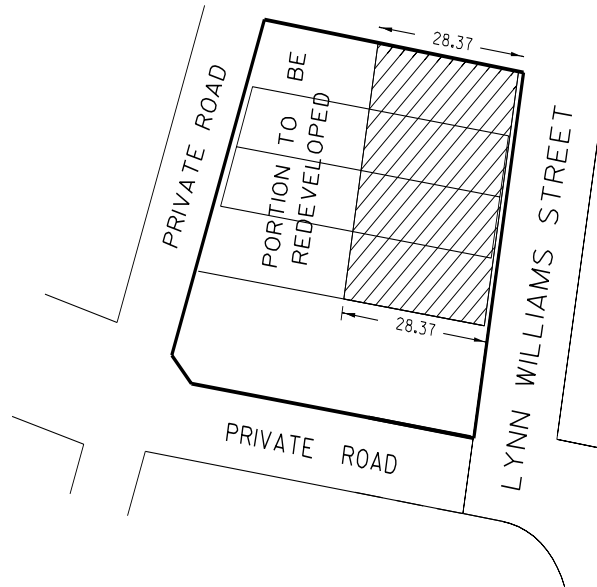
MAP 5

PORTION OF EXISTING BUILDING TO BE RETAINED

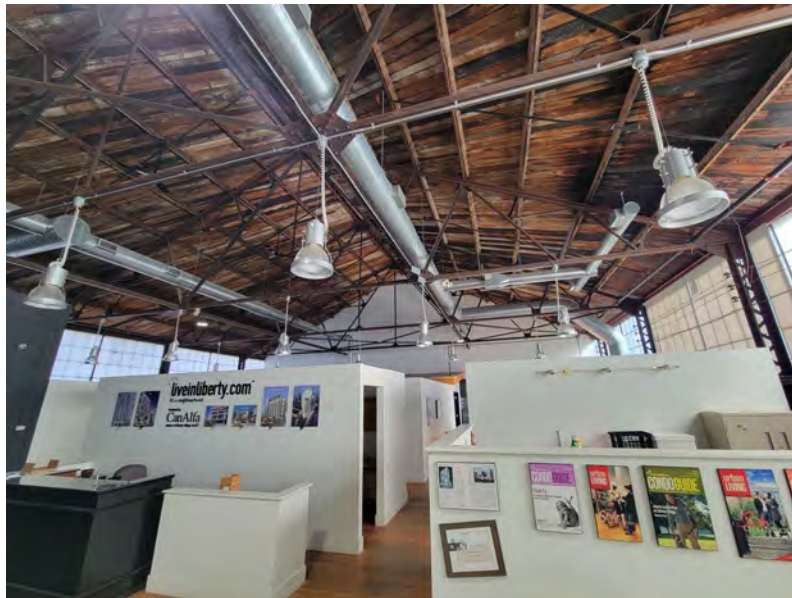
Photo 4: View of the interior at mezzanine level looking north

The roof over the central bay is framed with steel trusses spanning the full 19.5 m span, which is covered with two layers of wood decking laid diagonally over each other in opposing directions. The sloped roof decking is supported by steel channels with wood-nailed plates. The steel roof trusses are supported on steel columns with chords constructed with double angles and latticed together with steel plates.

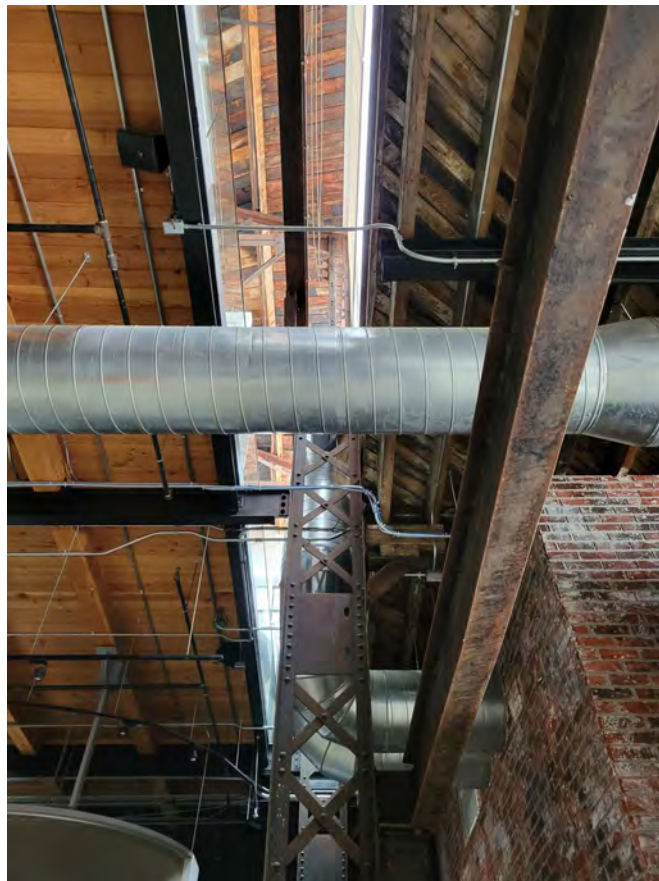
Photo 5: View of typical interior column

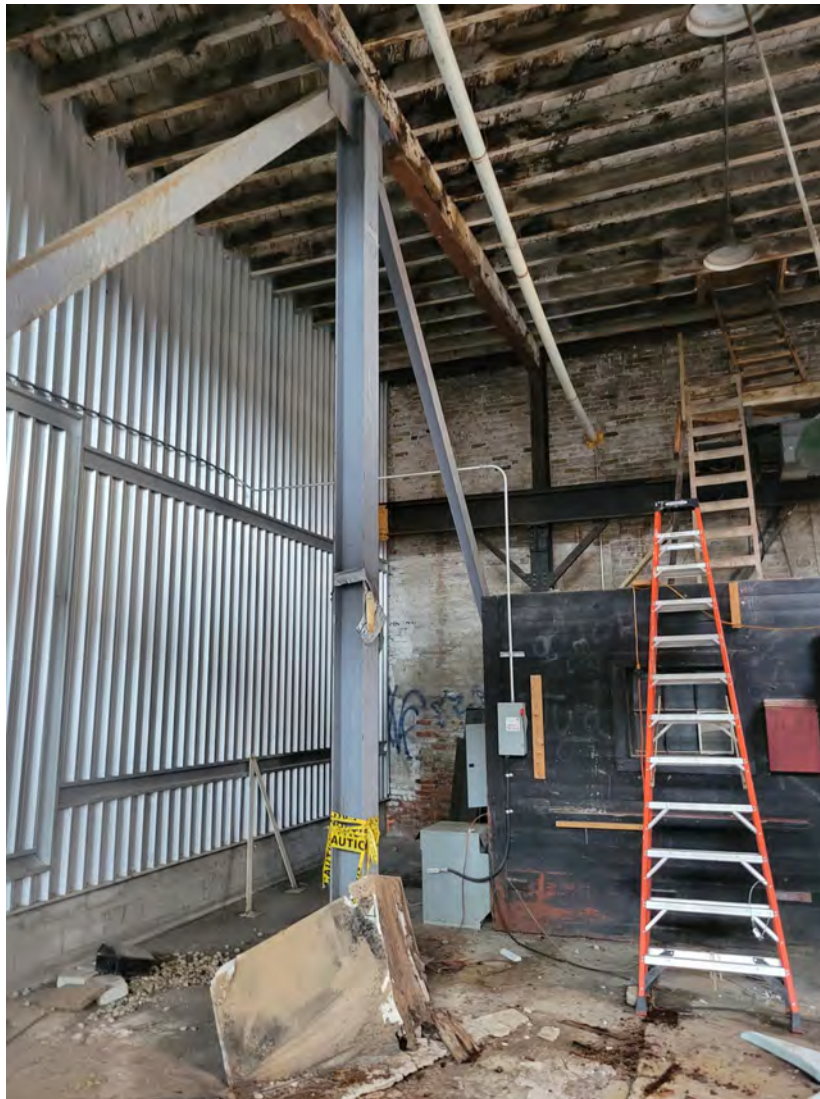
Photo 6: Existing vertical bracing installed in 2005 along grid line 7

- The existing building structure to remain should be a stand alone structure from the new building construction with a continuous separation and expansion joint.

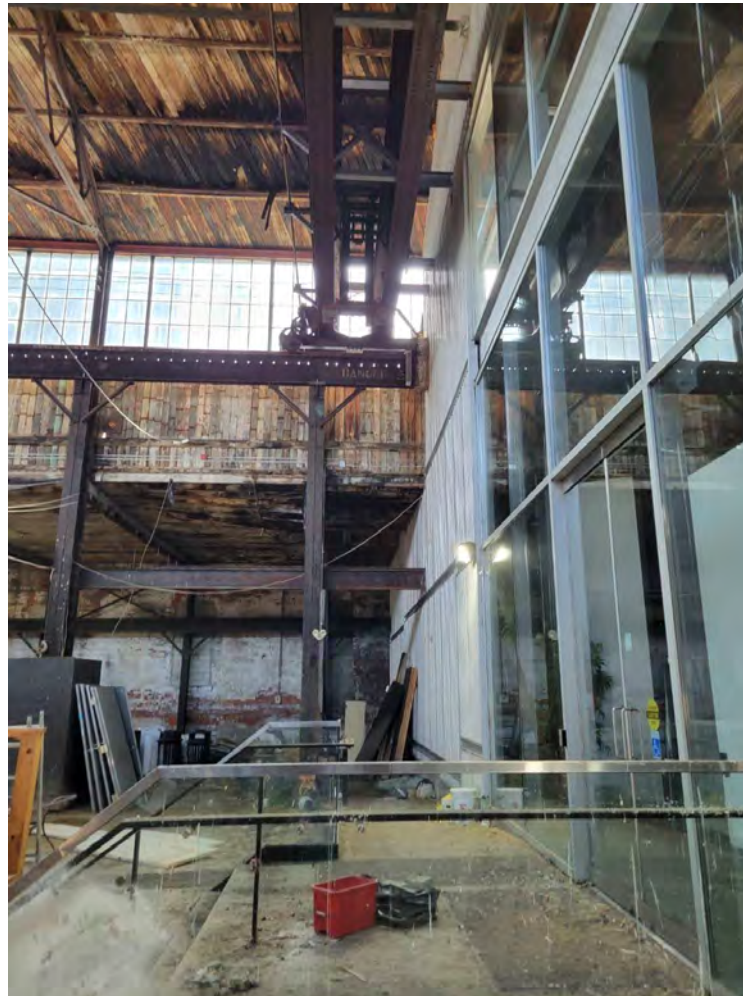
Photo 7: Existing gantry crane located just south of grid line 7

We recommend to consider maintaining the gantry crane in its current location. We understand the design intent is to have existing crane beams extend slightly north of grid line 7. Short stub column supports could be added between the underside of the gantry crane north girder and the top of crane beam supports in line with the columns on grid line 7. This would allow the beams north of grid line 7 to be cut and removed beyond approx. 1m north of grid line 7.

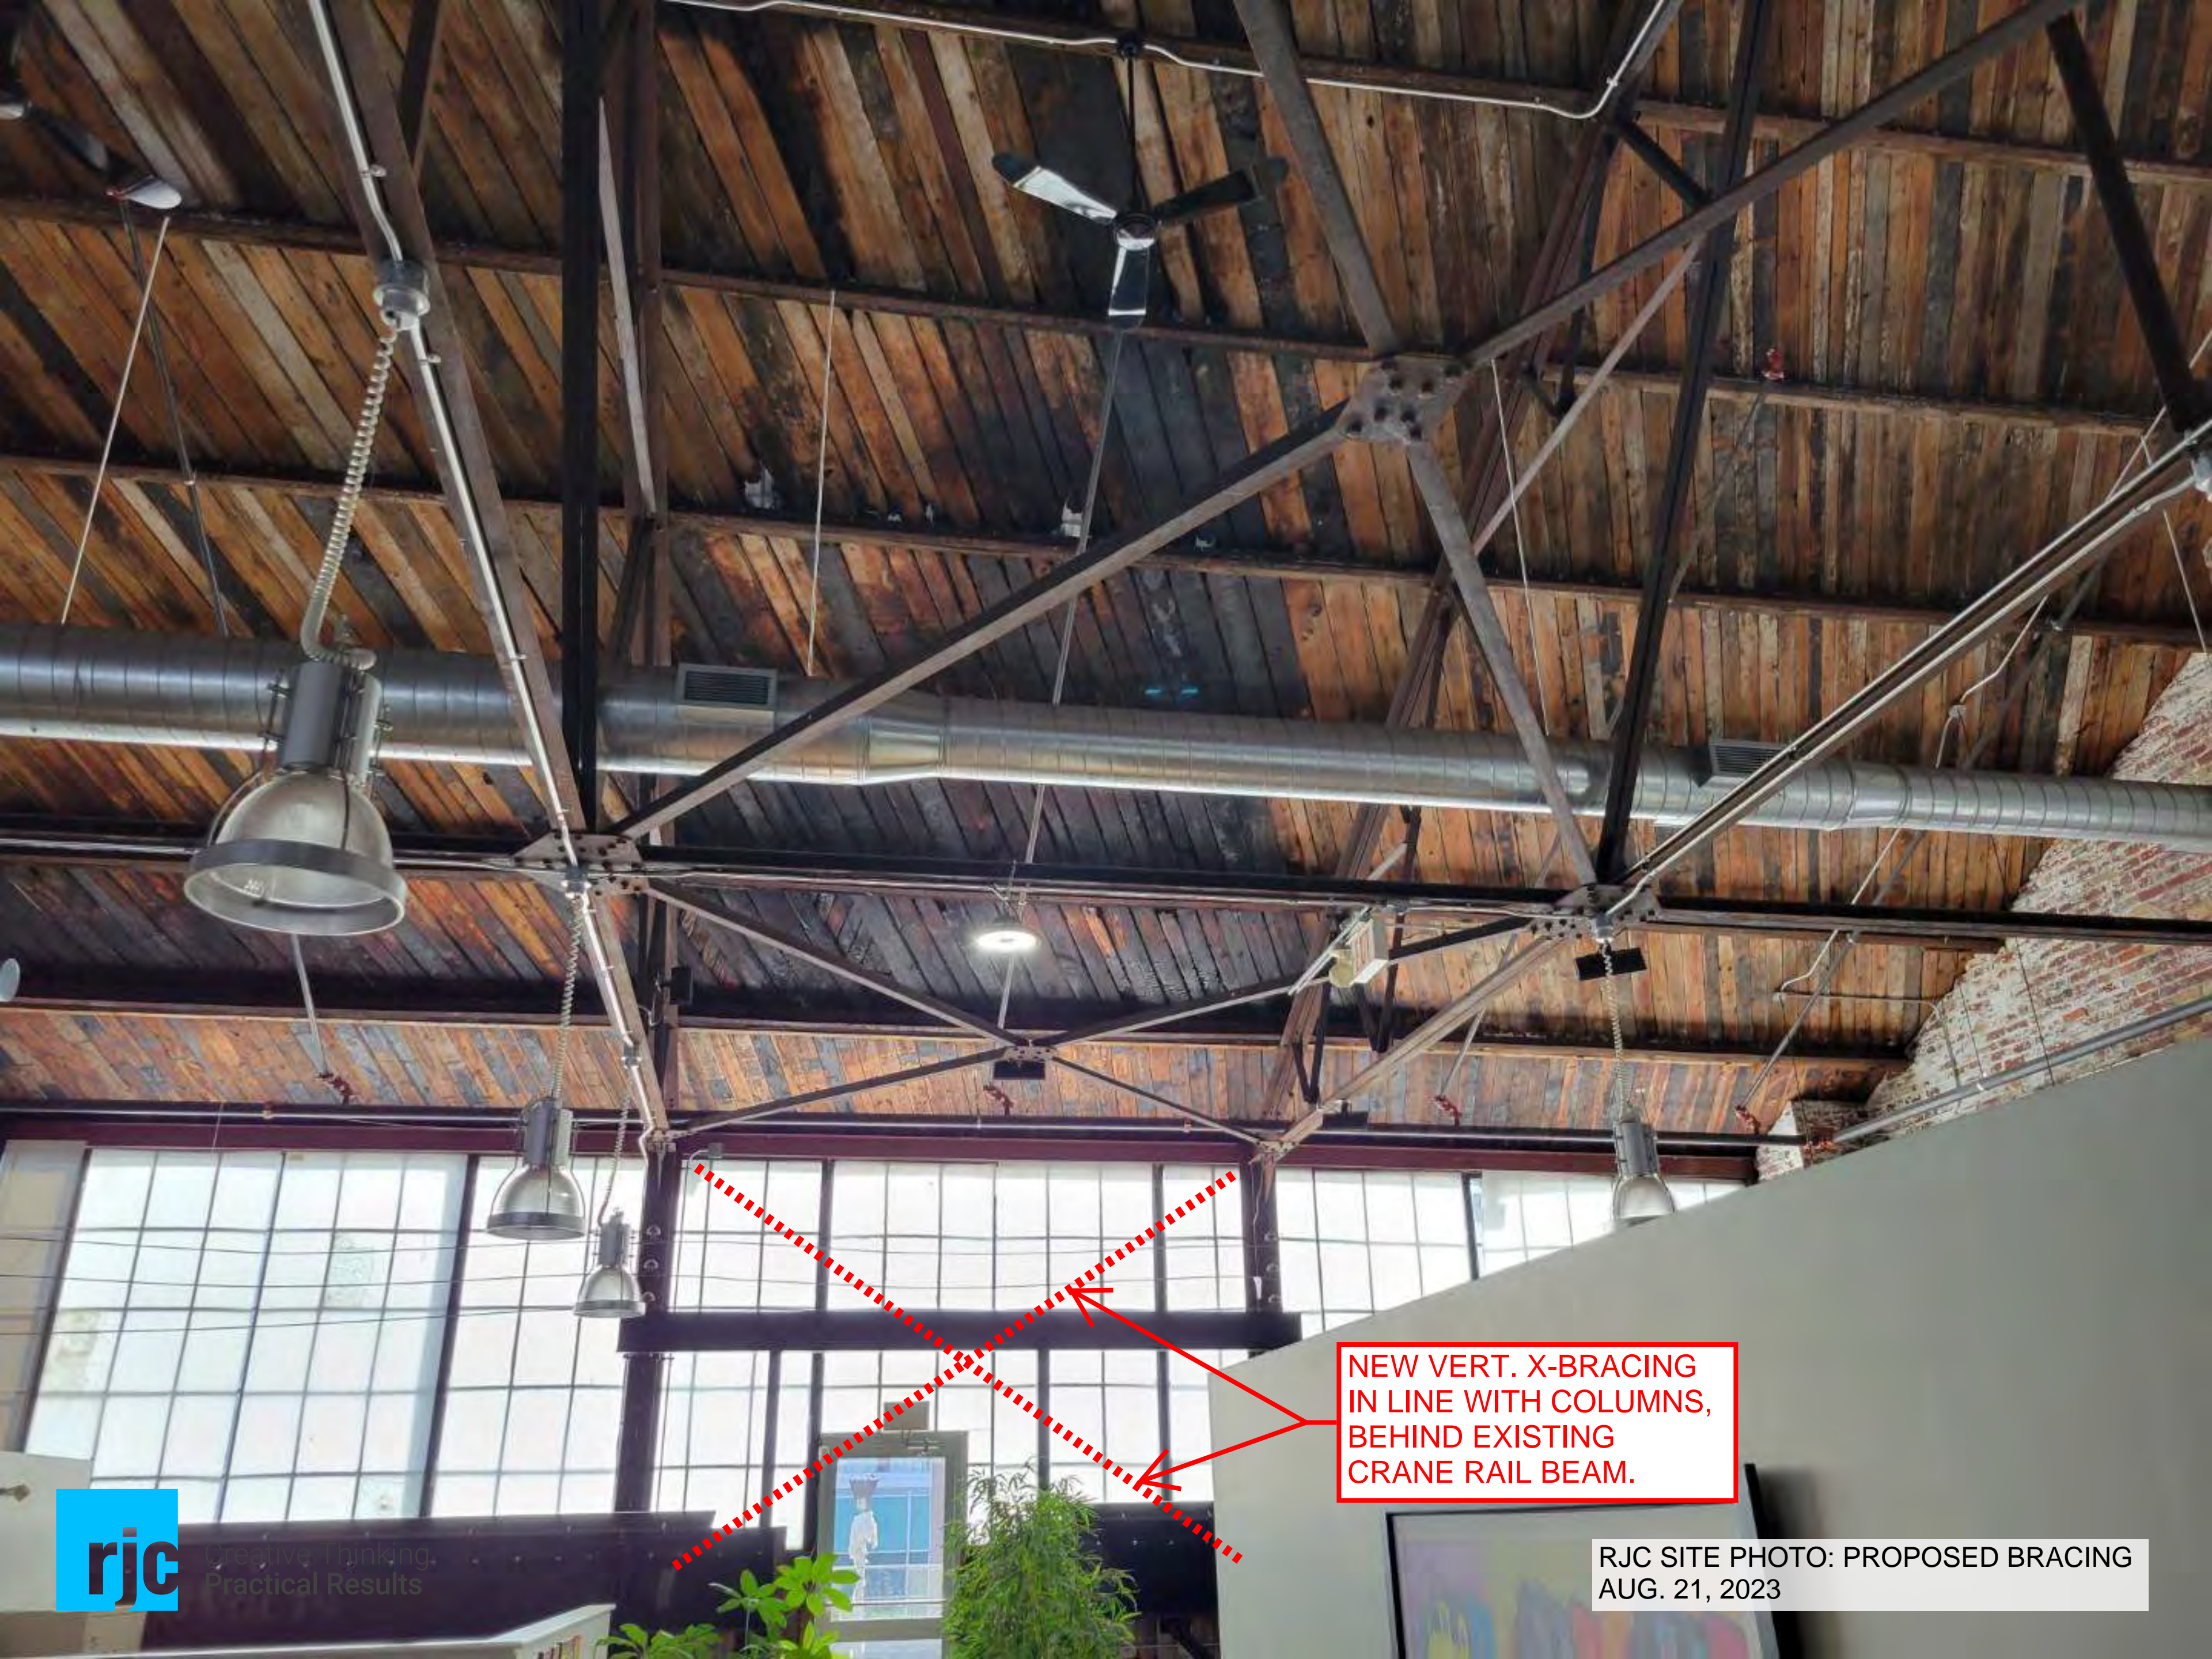
RJC SITE PHOTO: PROPOSED BRACING
AUG. 21, 2023

NEW VERT. X-BRACING
IN LINE WITH COLUMNS,
BEHIND EXISTING
CRANE RAIL BEAM.

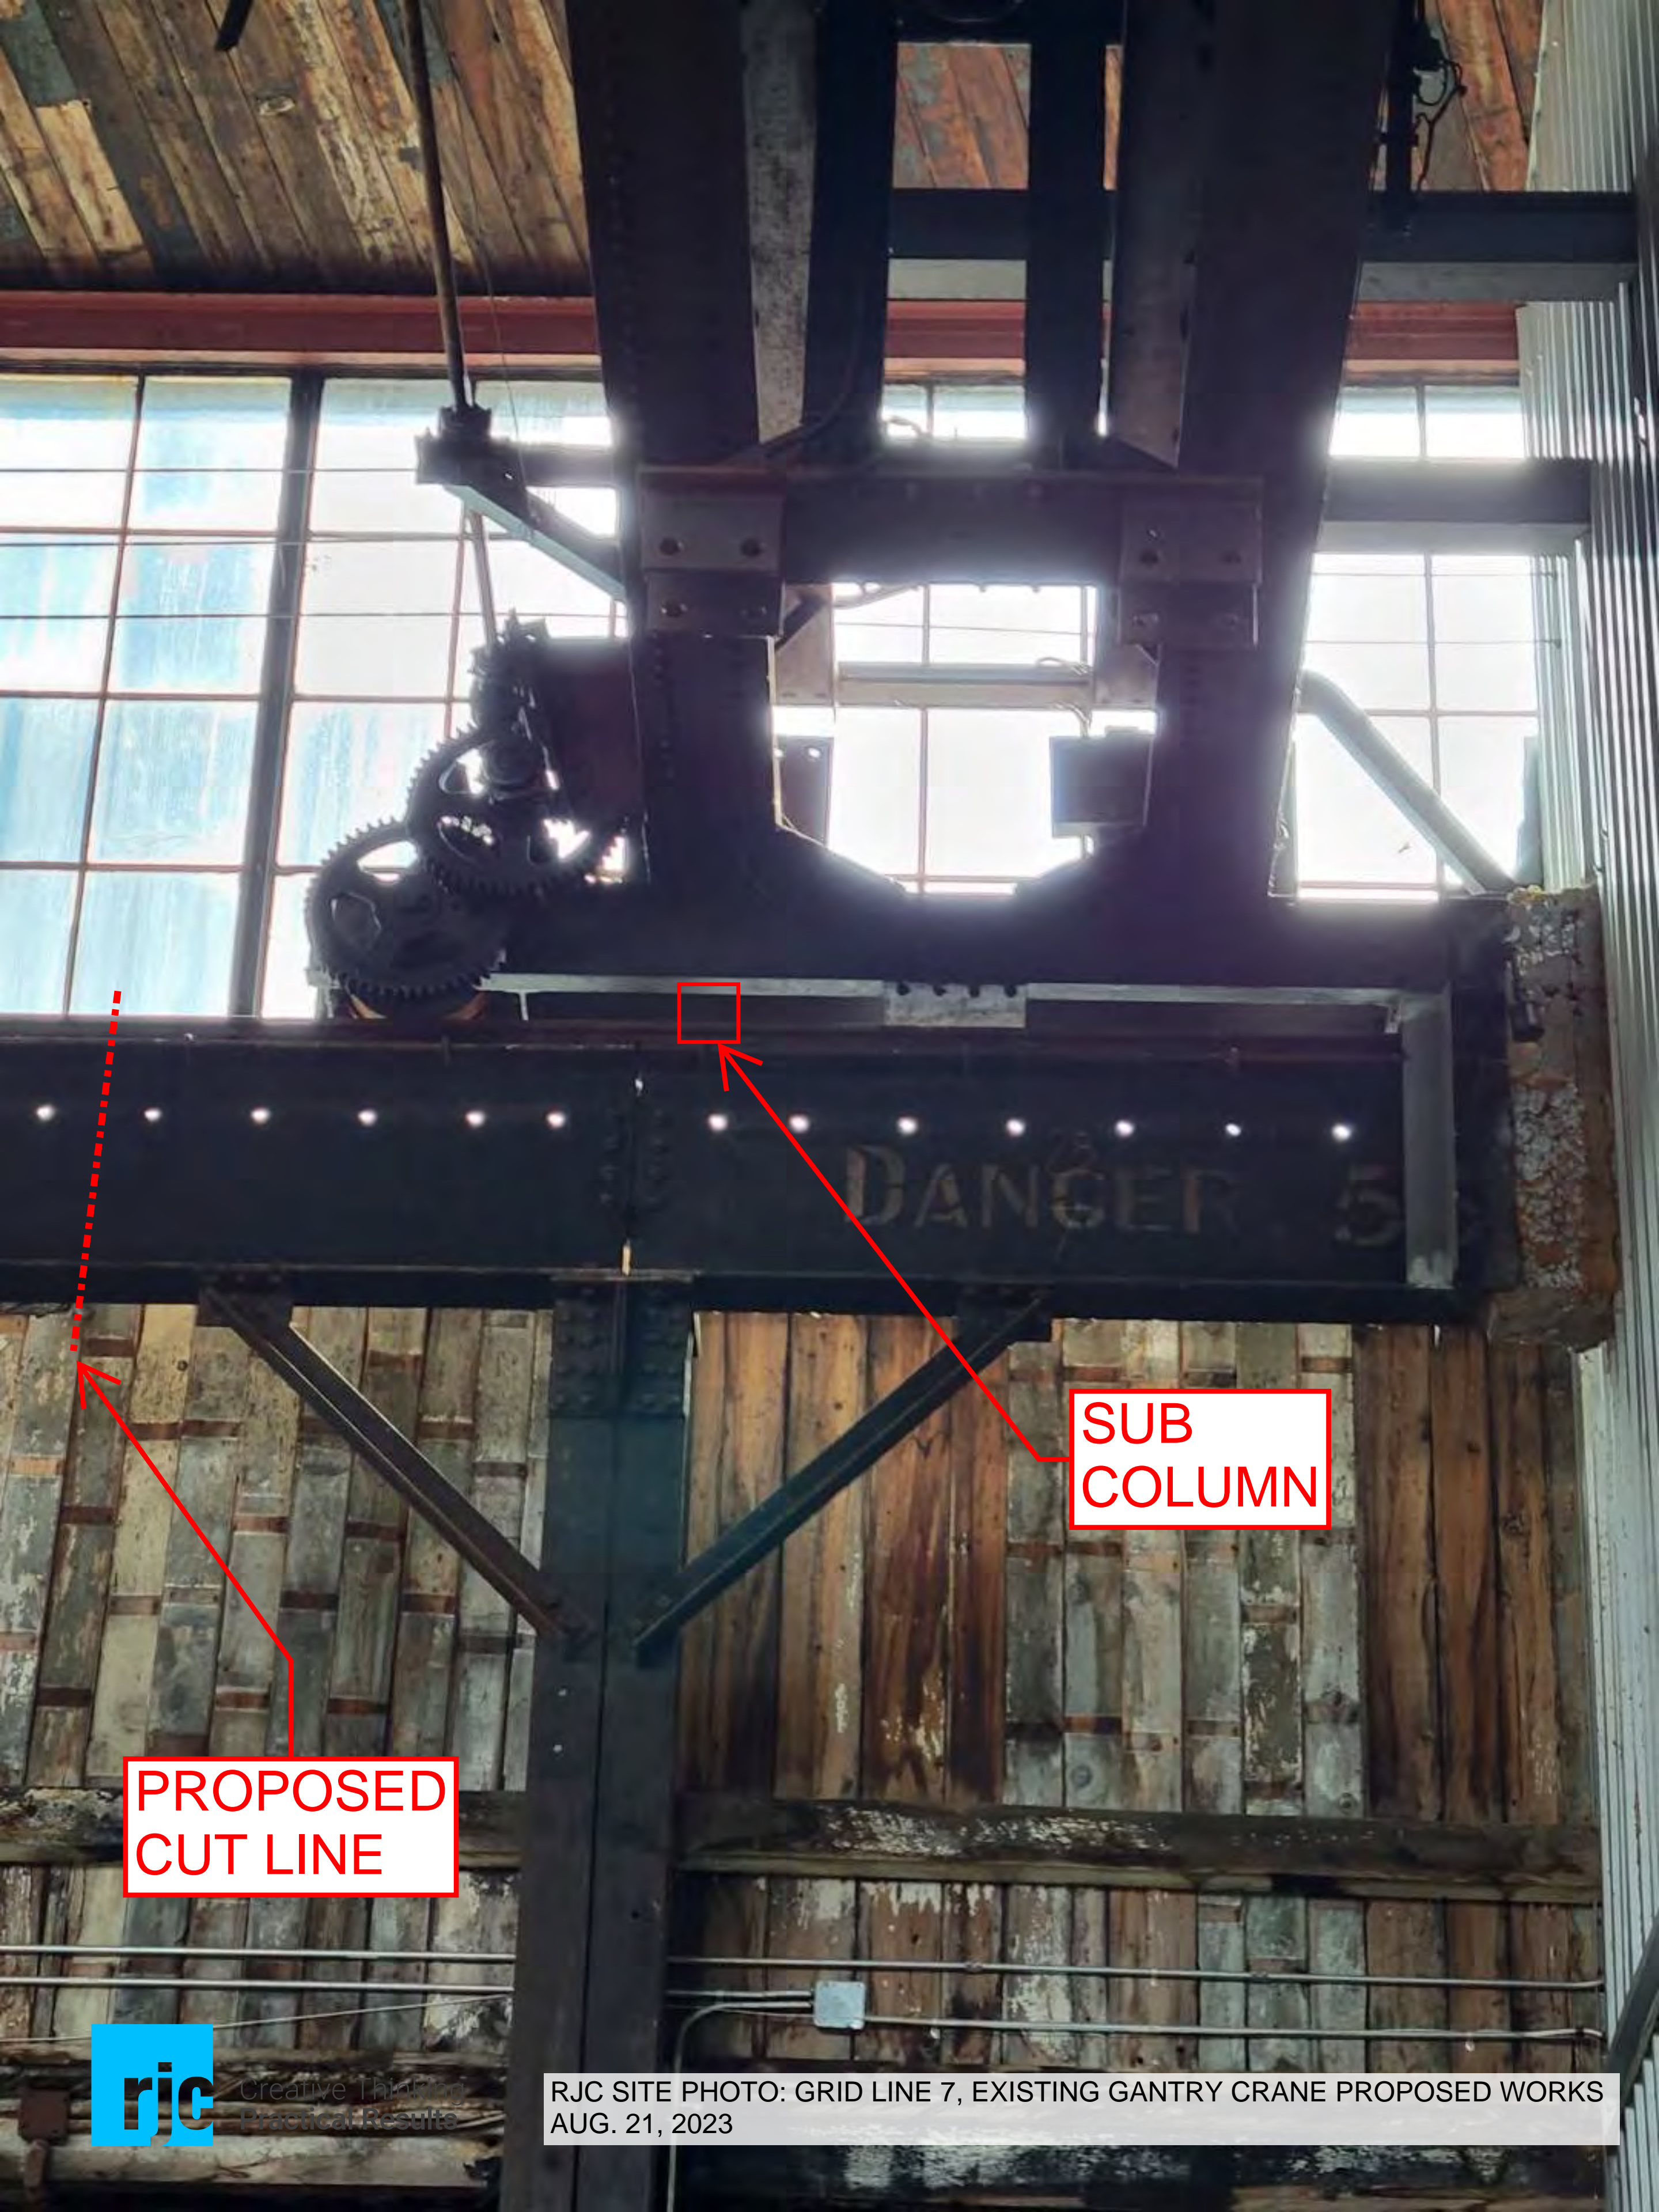
RJC SITE PHOTO: GRID LINE 7, EXISTING GANTRY CRANE PROPOSED WORKS
AUG. 21, 2023

SUB
COLUMN

PROPOSED
CUT LINE
